WOOD DESTROYING ORGANISM ATTACHMENT TO THE WOOD DESTROYING INSECT INFESTATION REPORT (NPCA-1)

Inspection Address: 27 Maple St.
Inspector: Tom Violente.

Inspection Company: Independent Home Inspections.
Co. Address and Phone: 15 Kent Drive
North Haven, CT. 06473 (203.448.6336)

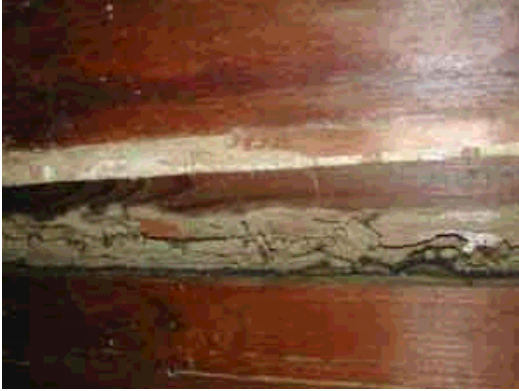
Mud tubes in basement door jamb.

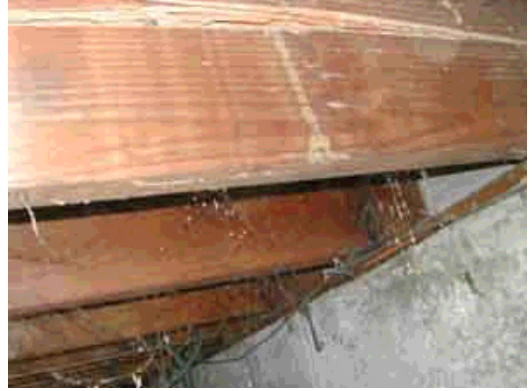
Damaged floor joists under kitchen.

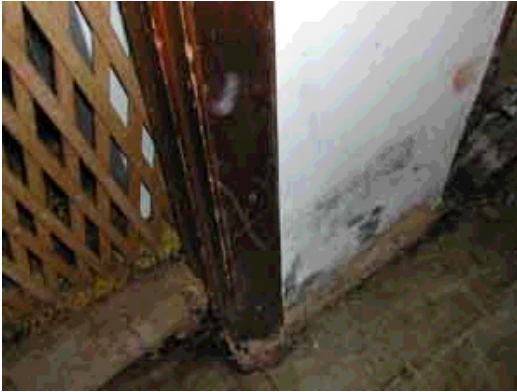
- A. NO VISIBLE EVIDENCE OF WOOD DESTROYING FUNGI WAS OBSERVED
- B. VISIBLE EVIDENCE OF WOOD DESTROYING FUNGI WAS OBSERVED AS FOLLOWS:
- Fungi observed; (description and location): Fungi growth was observed in the laundry area common to the entry door jambs and baseboards. (See photo #3)

Damage from wood destroying fungi is noted in the following area(s): Laundry Room.

Fungi growth in laundry room.

Treatment Recommended

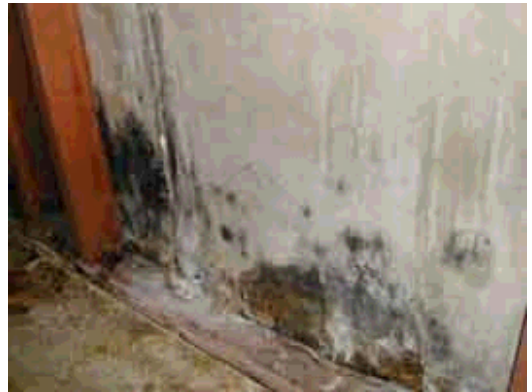
There is evidence of the presence of excessive moisture conditions in untreated wood as follows:
Mold growth and wood rot was observed in the accessible areas of the basement level laundry wall framing and sole-plates

Mold growth behind laundry wall.
