Commercial Property Condition Assessment

123 Main Street
Your Town, Ct. 06400

CR2364

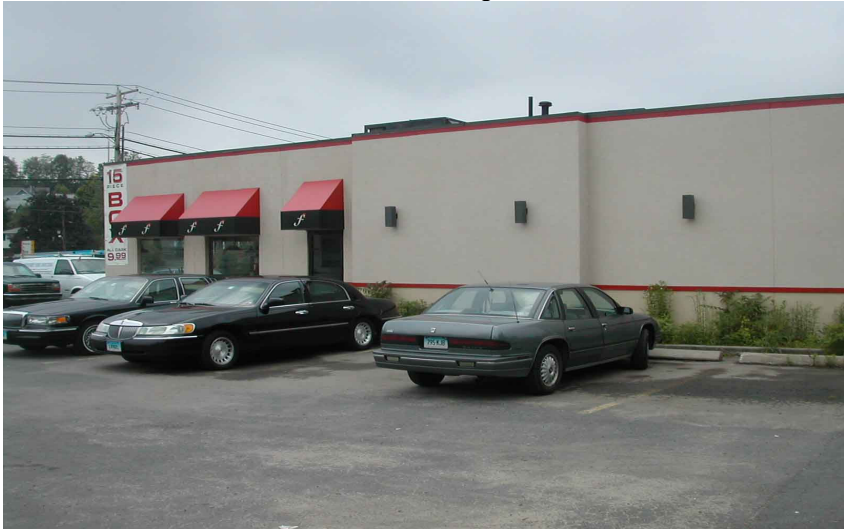
Photo 1: North building elevation

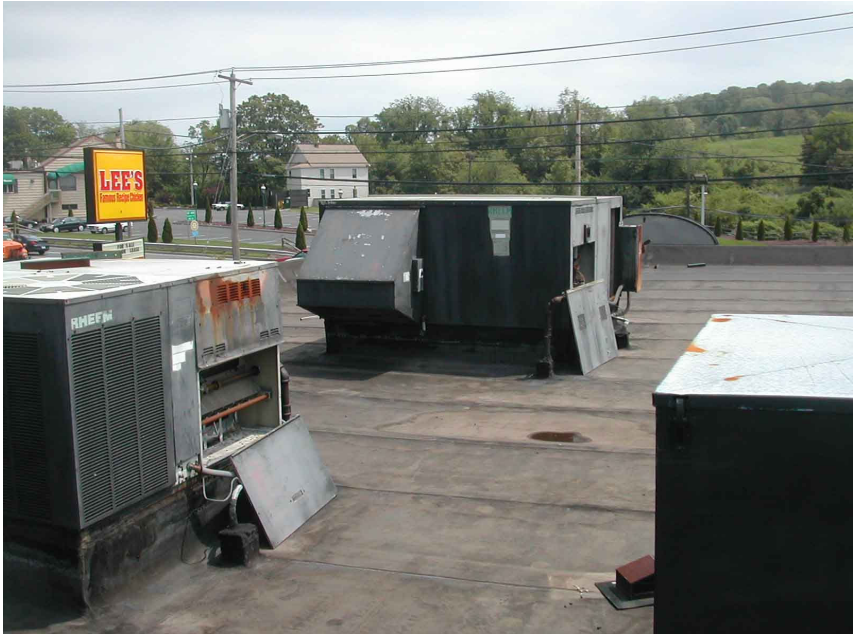
Photo 2: General Roof Area

Rigid foam insulation, valued at approximately R-10, was noted on the roof.

12.2.2 The recommended amount of insulation in flat roofs is R-10 to R-20. The current amount of insulation is considered acceptable.

No evidence of corrosion of the steel roof deck was noted.
